3 IMPACT OF SEA EROSION ON SUSTAINABLE COASTAL TOURISM DEVELOPMENT IN GHANA. THE CASE OF SALTPOND BEACH RESORTS

Eric Kojo Wu Aikins

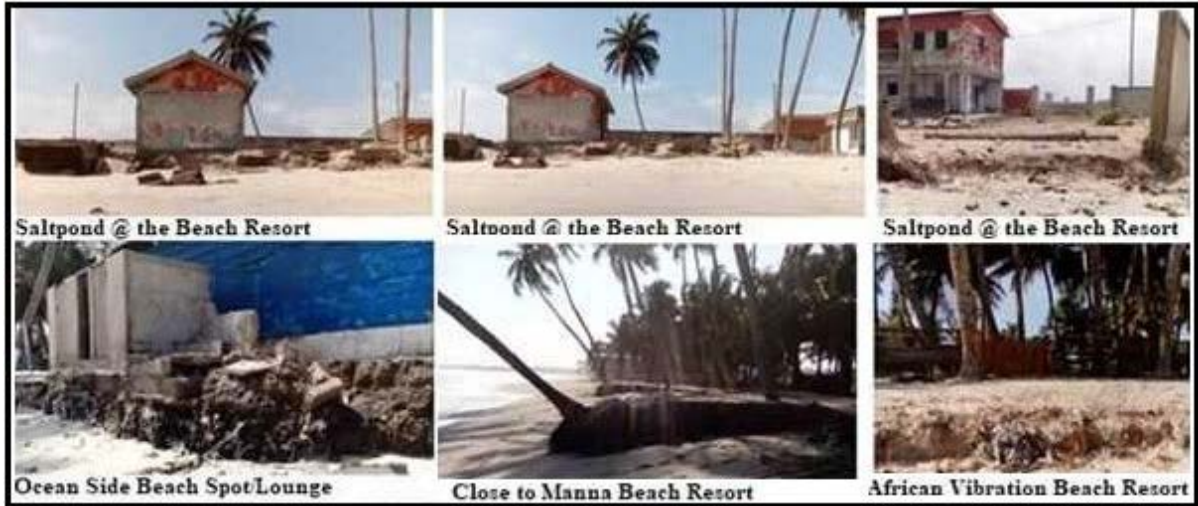
Figure 1: Photographic Evidence of the Destructive Impact of Sea Erosion along the Coast of Saltpond.

One of the important evidences of the negative impact of sea erosion on sustainable urban coastal tourism development in Ghana is the destruction of some beach resort facilities in the study area. Currently, Saltpond @ the Beach Resort has closed down due to the negative impact of sea erosion that resulted in the breakdown of the front wall and some parts of the bar of the beach resort in 2023 (Figure 1). This has rendered the beach resort

unsafe for public use. Similarly, Figure 1 shows additional damaging effect of sea erosion in the front part of Ocean Side Beach Spot/Lounge where sea erosion has broken down part of the spot's washroom facility and the frontage of the spot. Also, Figure 1 shows the effect of sea erosion along certain parts of the coast of the study area where coconut trees along the beach have been removed or are almost removed from their stable ecological settings.

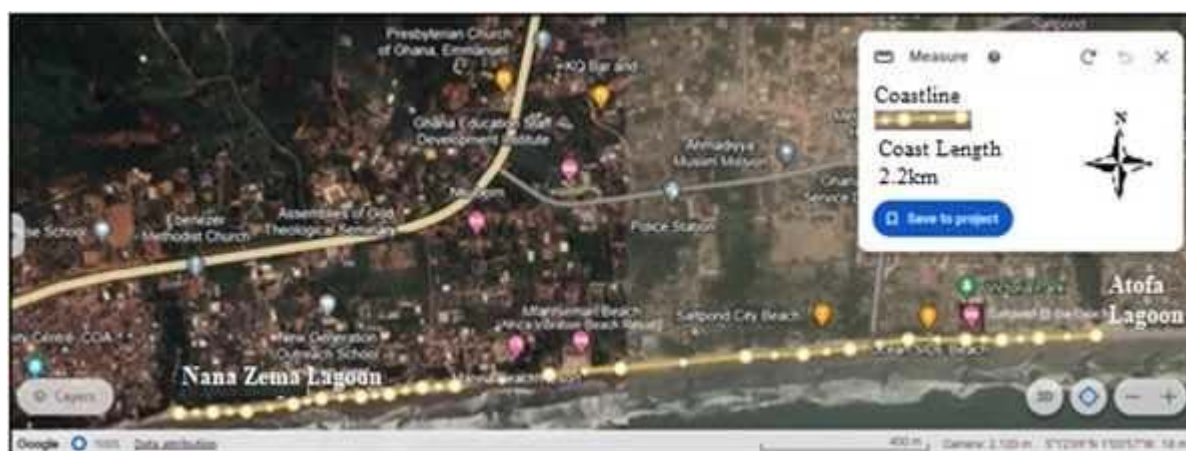
Figure 3: The Coastline of Saltpond.

The coastline of Saltpond (i.e. only the upper town of Saltpond) covers about 2.2km (from the Atofa lagoon located between Saltpond Upper and Lower towns in the east to Nana Zema lagoon in Kormantse in the west) of the 21km coastline of the Mfantseman Municipality's stretch of the most

beautiful beaches in Ghana, which are about 60 metres above sea level (Figures 2 and 3; Mfantseman Municipal Assembly, 2021; Ghana Statistical Service, 2014). A total of six beach resorts mark the beautiful sandy beach of Saltpond. This makes the town one of the most attractive tourist and recreational destinations for both domestic and foreign tourists that travel to Saltpond to enjoy the sunny, clean and beautiful beach that the town offers.

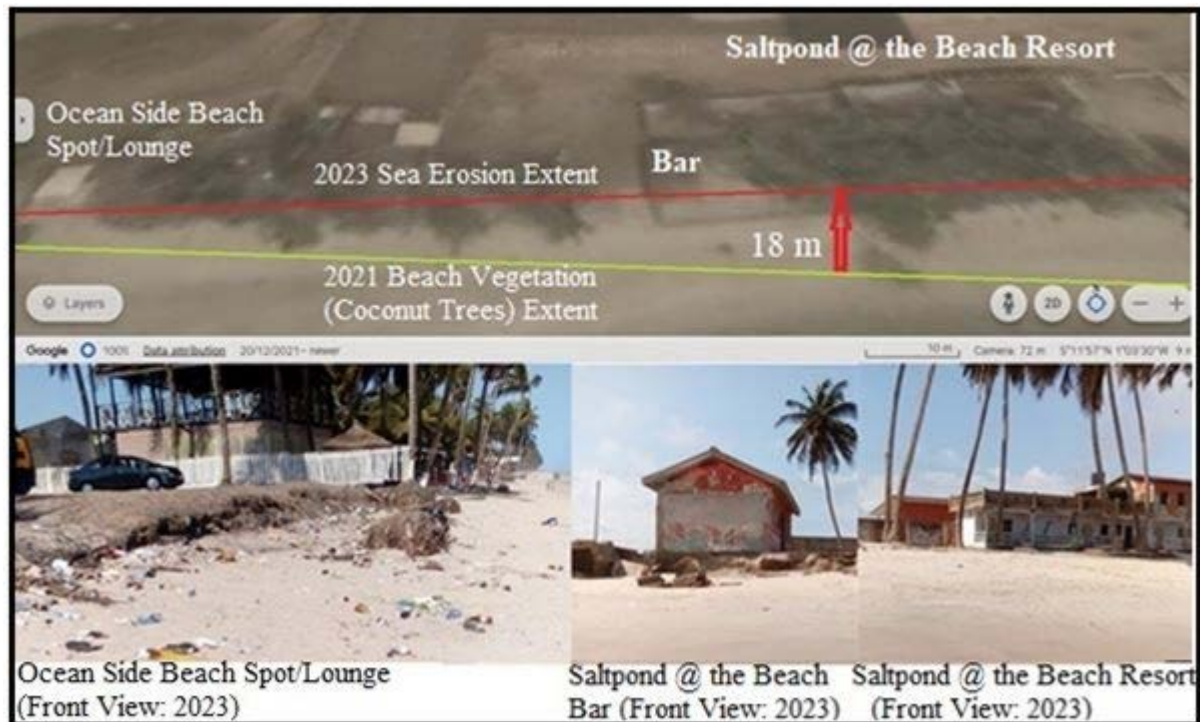
Figure 5: Removal of Coastal Vegetation along Saltpond Beach between 2021 and 2023.

Overall, this result is consistent with the results of the photogrammetric analyses in Figure 5 that shows that a sizeable proportion (about 18 metres) of the coastal vegetation (coconut trees in front of Saltpond @ the Beach Resort) has been removed by sea erosion between 2021 and 2023.

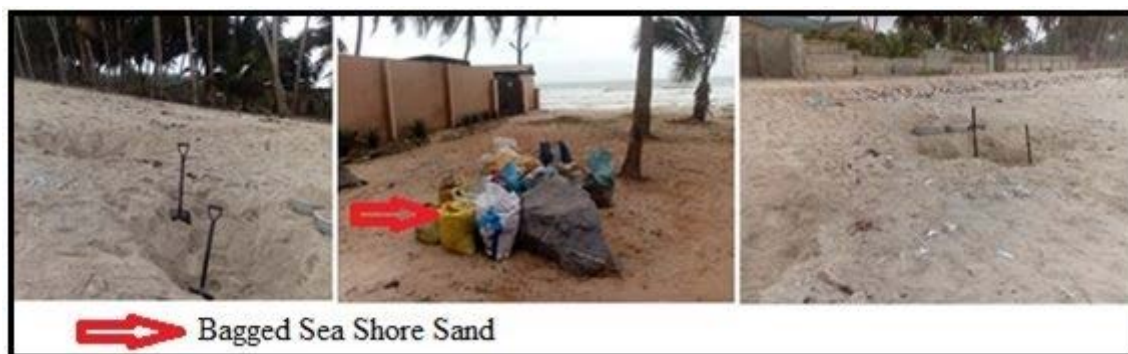
Figure 6: Photographic Evidence of Sea Shore Sand Winning.

In the study area, sand winning activities were found to be prevalent. For instance, Figure 6 shows areas where sand winning activities had taken place during the period that the study's survey data collection and field observations were conducted. Also, Figure 6 shows the presence of shovels and spades that had been used to win sand a moment before the arrival of the researcher at the affected location in the western end of Saltpond coast.

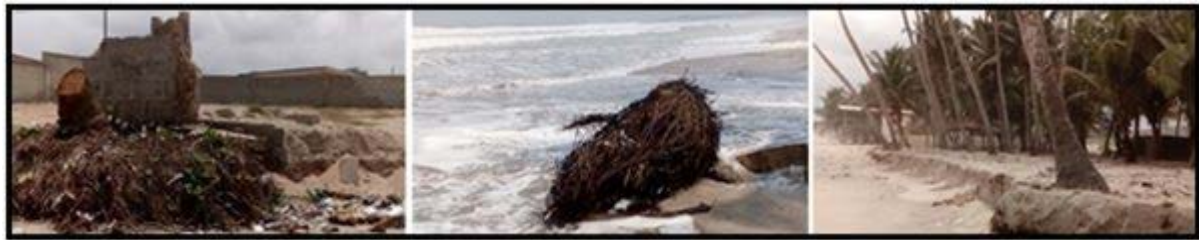
Figure 7: Photographic Evidence of Coconut Trees Destroyed by the Sea Erosion.

vegetation along the coast of Saltpond. Figure 7 provides evidence of both natural (removal of coconut trees by sea erosion) and human induced destruction of beach coconut trees (cutting of coconut trees to make way for the construction of beach resort and beach housing facilities). Traditionally, the presence of coconut trees and other coastal vegetation including mangroves are found to help provide vital ecosystem support and services that help sustain coastal ecologies and environments (Jarungrattanapong & Manasboonphempool, 2009). For instance, the roots of beach coconut trees help bind the loose beach sand together and prevent the sand in coconut trees covered areas from being easily washed away by the sea water.

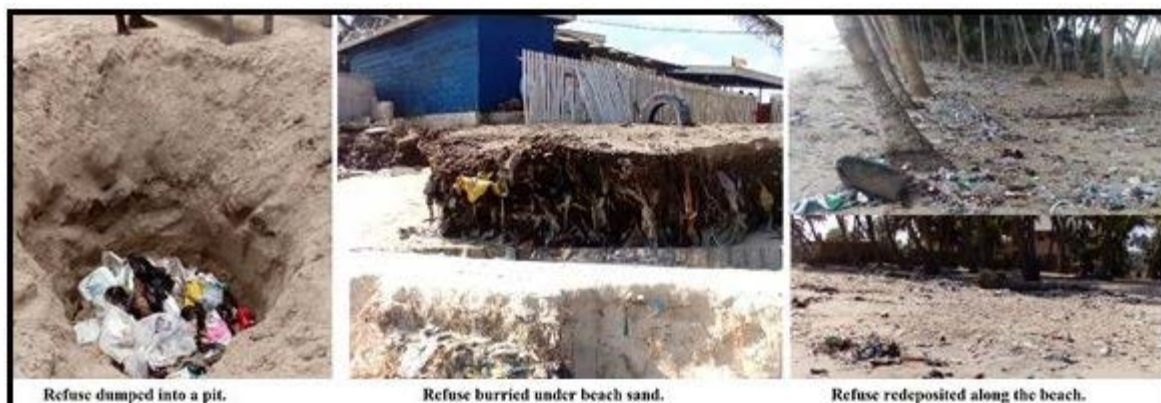
Figure 8: Photographic Evidence of Re-littering of Saltpond Coast through Sea Erosion.

Figure 8 portrays the distribution of litter and refuse that has been deposited, accumulated and buried along the coast of the study area. Although on the surface Saltpond beach could be considered to be among the cleanest beaches in Ghana some portions of the beach below the surface are filled with litter. Through beach resort operators' watchfulness cleanliness and sanitation of Saltpond beach has improved considerably. For instance, some beach resort operators have managed to stop the public from dumping refuse along the coast. Nevertheless, the coast of Saltpond could be re-littered overnight through incessant sea erosion that remove the top beach sand cover including coconut trees that allow the accumulated buried refuse to be unearthed and redistributed along the coast of the study area. This phenomenon could be attributed mainly to the removal of coconut trees along the coast due to sea erosion.
